PHASE I ENVIRONMENTAL SITE ASSESSMENT

5454 Venoy Road | Wayne, Michigan PM Project Number 01-6000-0-001

Re: Phase I Environmental Site Assessment of the RESA/MSU Extension Property Located at 5454 Venoy Road, Wayne, Michigan PM Environmental, Inc. Project No. 01-6000-0-001

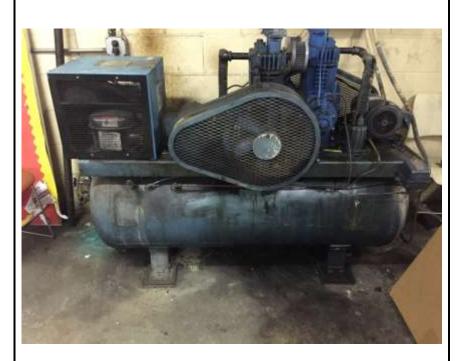
Photograph 23

Air Compressors: PM observed air compressors in the boiler rooms of the subject buildings. The air compressors were staged on concrete which was observed to be in good condition, free of significant damage or cracking. No significant staining was observed in the vicinity of the air compressor. Based on these observations, PM has not identified the air compressors as a REC.

Air compressor located in the boiler room of the office building

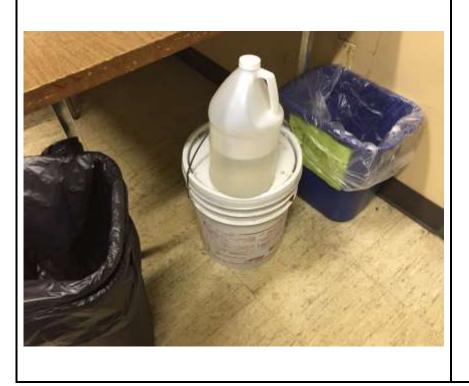
Photograph 24

Drums, Barrels, and/or Containers > 5-gallons: PM observed various 5-gallon containers of soaps, household grade cleansers, air compressor oil, and fertilizers throughout the buildings on the subject property. The containers were stored on flooring which was observed to be in good condition free of significant damage and/or cracking. No significant staining or evidence of release was observed. Based on this information, PM has not identified the containers as a REC.

Typical chemical storage on the subject property

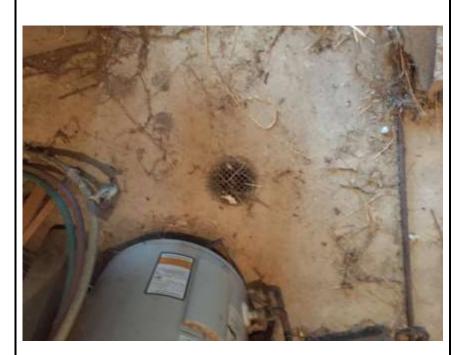
Photograph 25

Floor Drains, Trench Drains, etc.: PM observed floor drains within the restrooms, mechanical rooms, boiler rooms, locker rooms, and storage areas. No staining or evidence of poor waste

handling was observed in the vicinity of the floor drains. No chemical storage was observed in the vicinity of the floor drains. The floor drains likely discharge to the municipal sewer. Based on the historical office and community outreach operations and the site observations, PM has not identified the floor drains as a REC.

Typical floor drain on the subject property

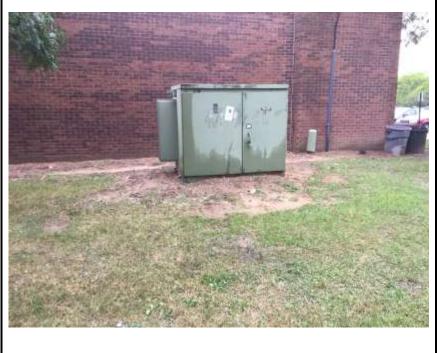
Photograph 26

Pad or Pole Mounted Transformers and/or Capacitors: PM observed a pad-mounted transformer associated with the office building. The transformer, which is likely owned by DTE Energy, did not contain a label indicating polychlorinated biphenyl (PCB) content. However, PM did not observe any staining or other evidence of damage or leakage.

Pad-mounted transformer, located on the east side of the office building
